EFFECTS OF AIRFRAME GEOMETRY
ON DOWNWASH PROBLEMS OF
TANDEM DUCTED-PROPELLER
VTOL AIRCRAFT

DATE Jan. 1964 REPORT NO. 179T80-6

Prepared Under Navy,
Bureau of Naval Weapons
Contract N0w61-0926-c

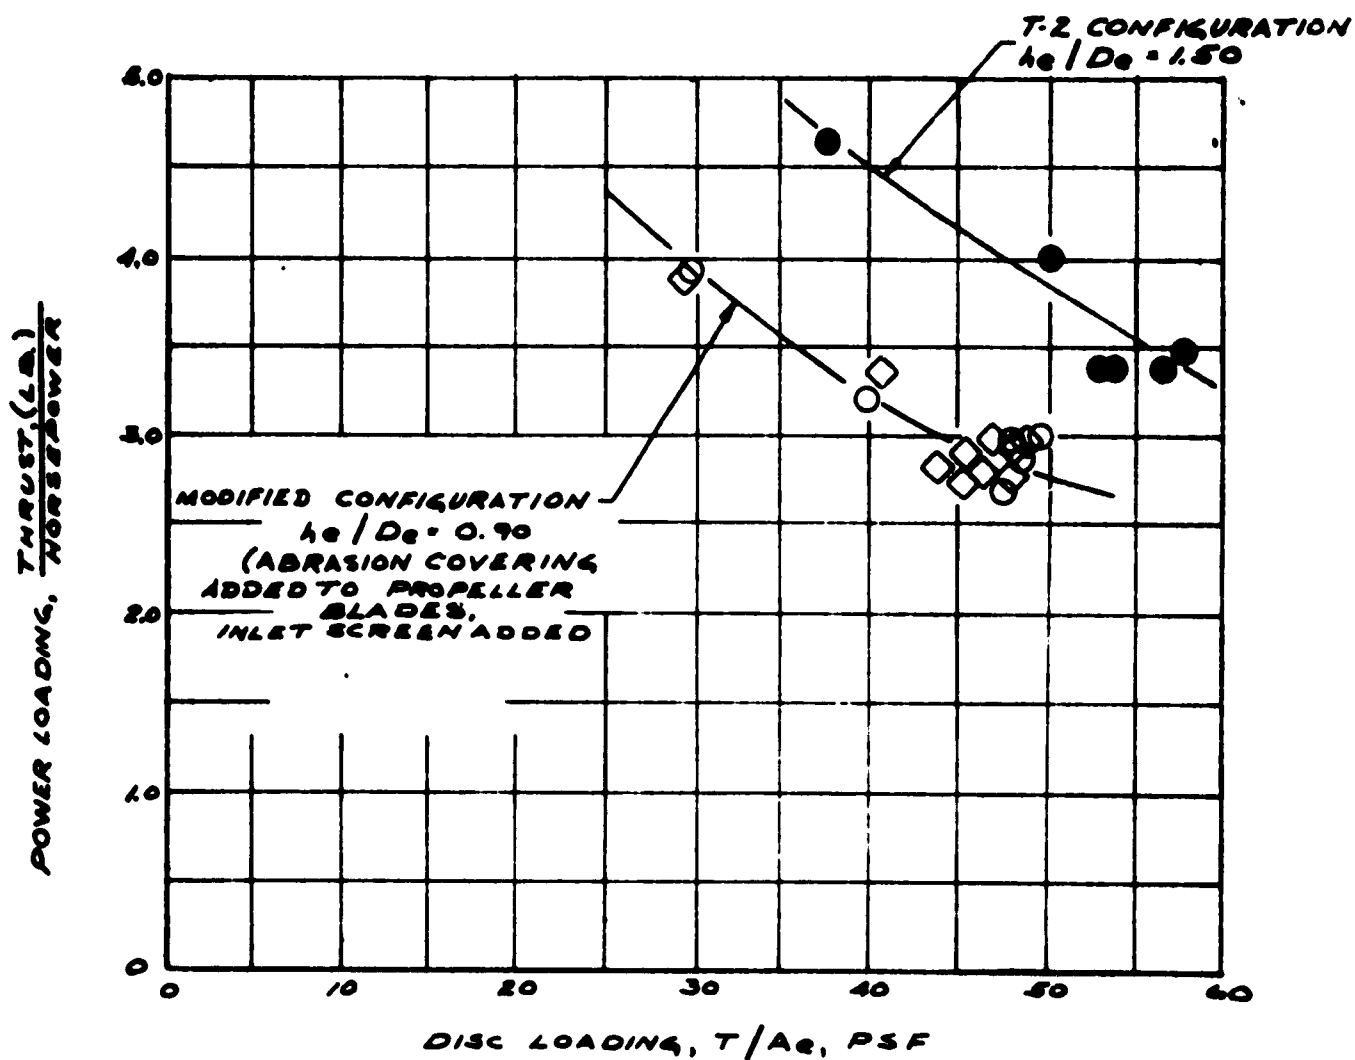
FIGURE 32. EFFECT OF HEIGHT AND CONFIGURATION ON POWER LOADING OBTAINED DURING TESTING OVER SAND

Figure 32 is a comparison of power loadings over sand for the T2 configuration and the Modified configuration under similar conditions. The significant loss in performance indicated by the plot is believed due to:

- a. The increased propeller surface roughness caused by the addition of the abrasion strip.
- b. The increased particle recirculation resulting from lower height operations.
- c. Increased power required from the addition of the rotating inlet screen.

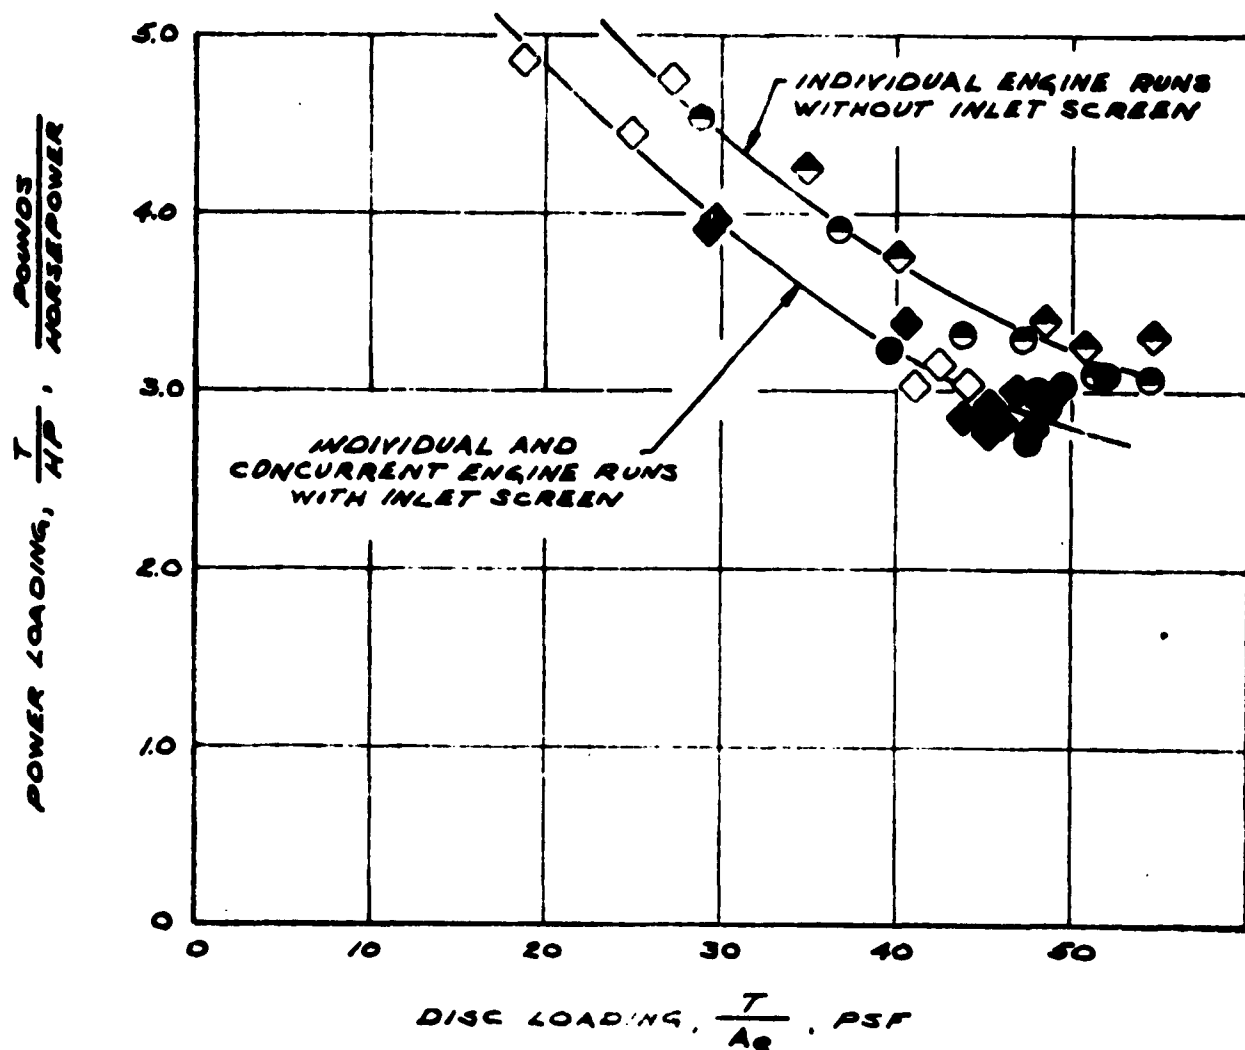
FIGURE 33. EFFECT OF INLET SCREEN ON POWER LOADING AT $h_e/D_e = 0.90$ FOR MODIFIED CONFIGURATION

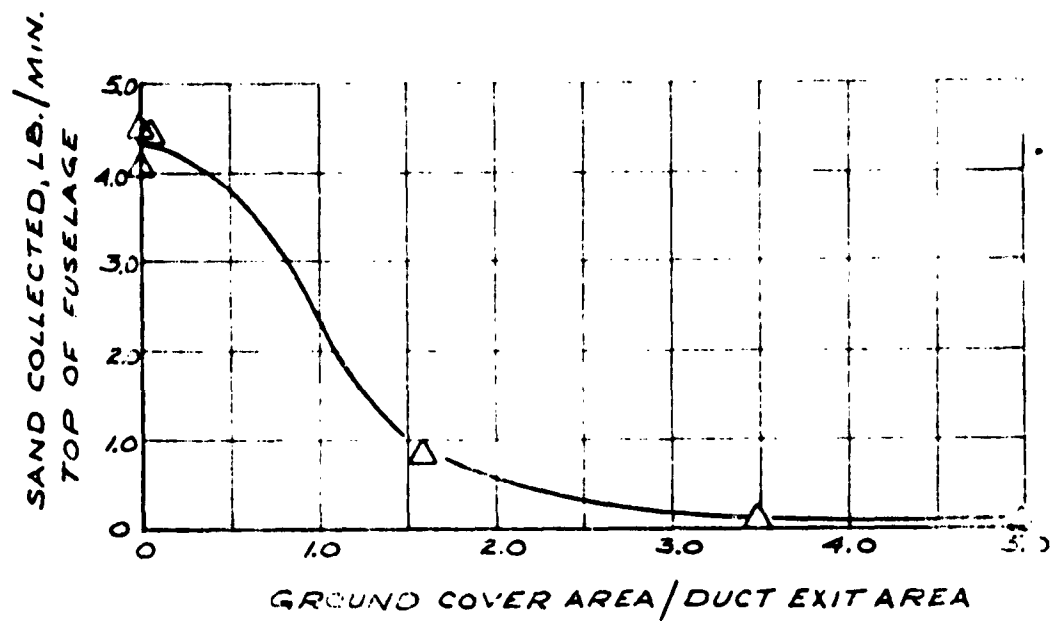
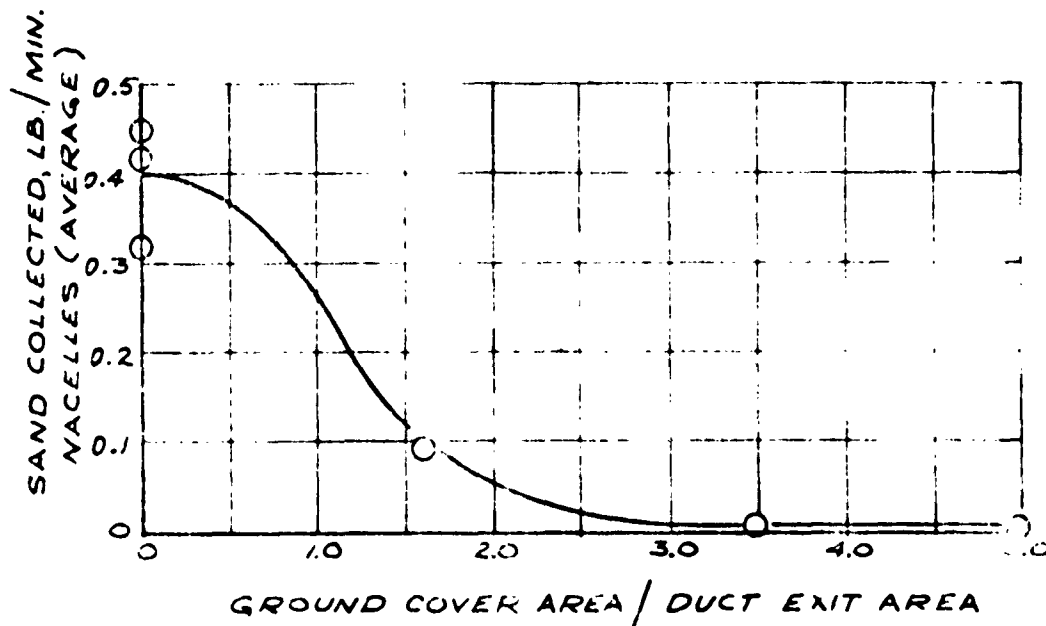
FIGURE 34. EFFECTIVENESS OF GROUND COVER IN PREVENTING FUSELAGE RECIRCULATION (DISC LOADING = 50 PSF)

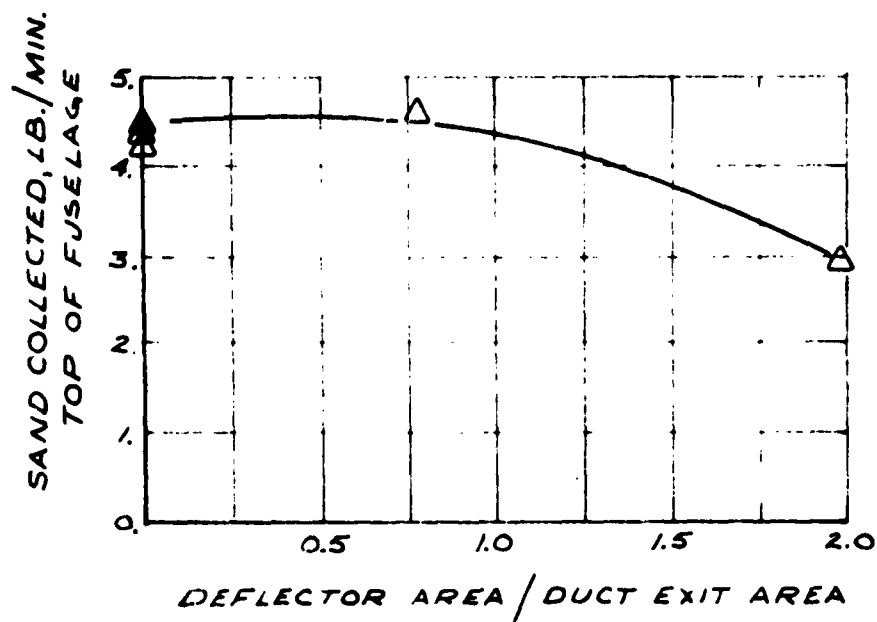
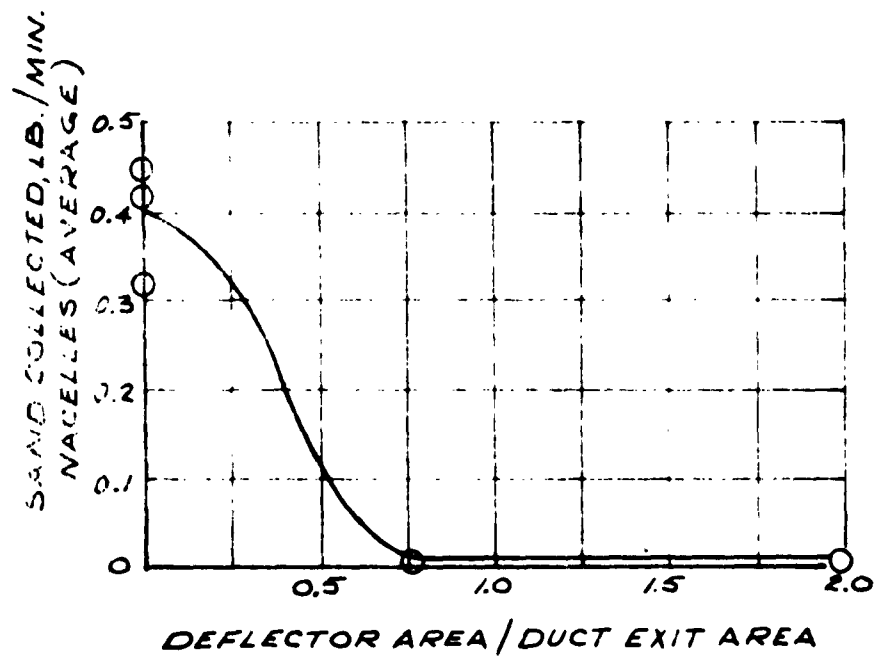
FIGURE 35. EFFECTIVENESS OF DEFLECTOR WING IN PREVENTING PARTICLE RECIRCULATION (DISC LOADING = 50 PSF)

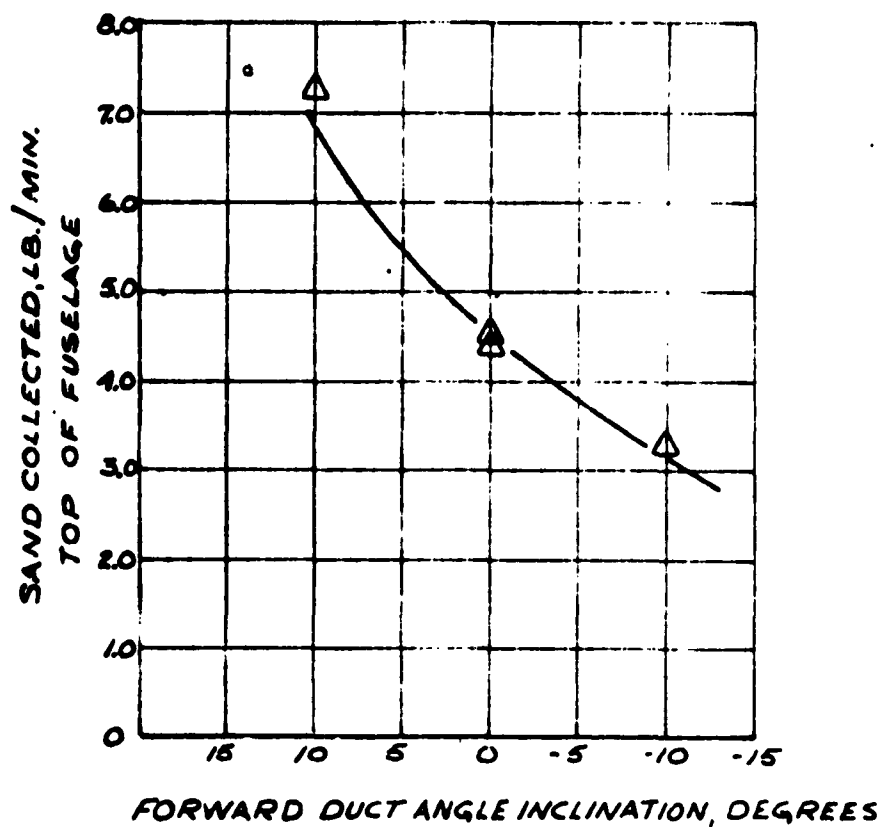
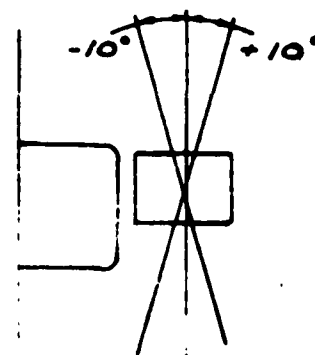
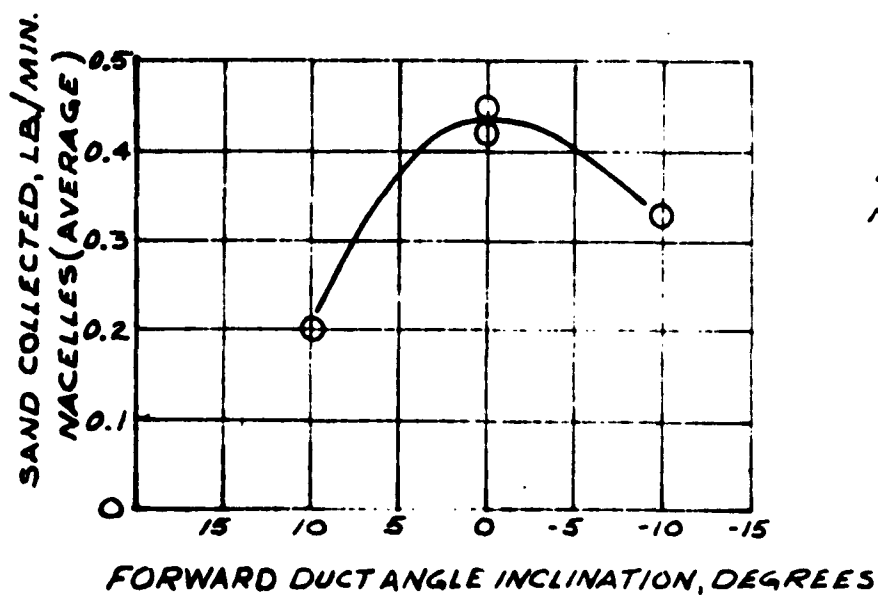
FIGURE 36. EFFECT OF LATERAL INCLINATION OF FORWARD DUCT ON PARTICLE RECIRCULATION (DISC LOADING = 50 PSF)

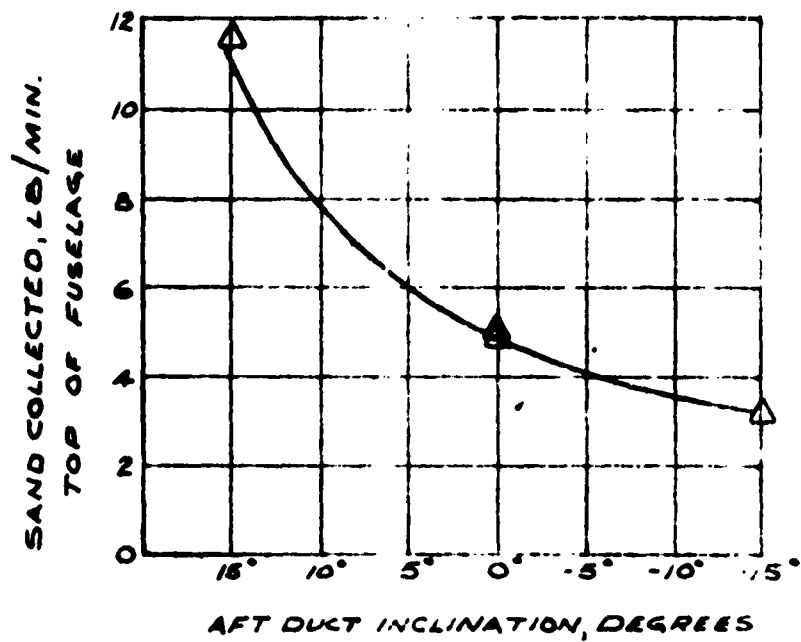
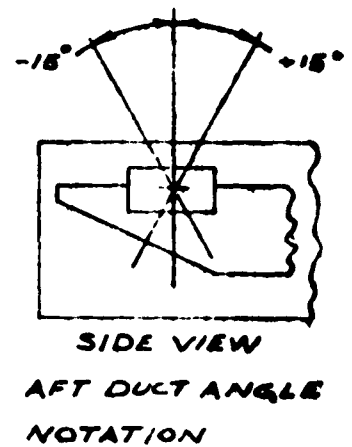
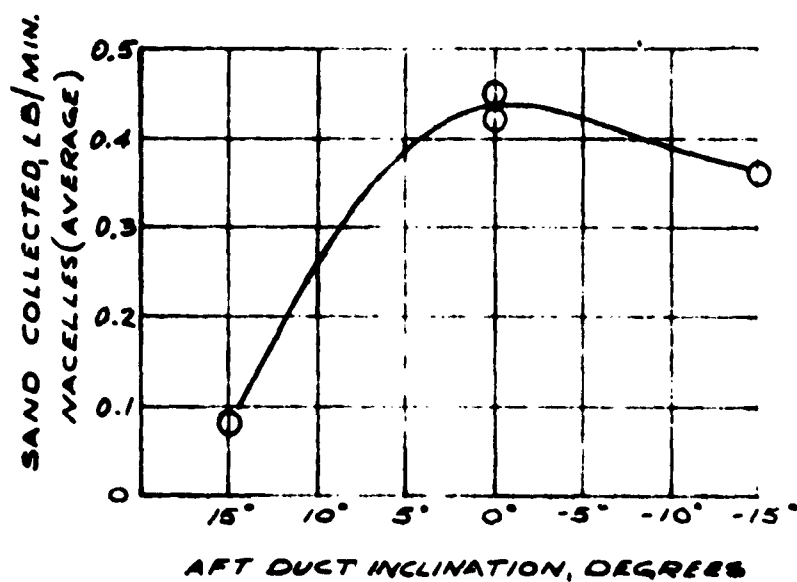
FIGURE 37. EFFECT OF LONGITUDINAL INCLINATION OF AFT DUCT ON PARTICLE RECIRCULATION (DISC LOADING = 50 PSF)

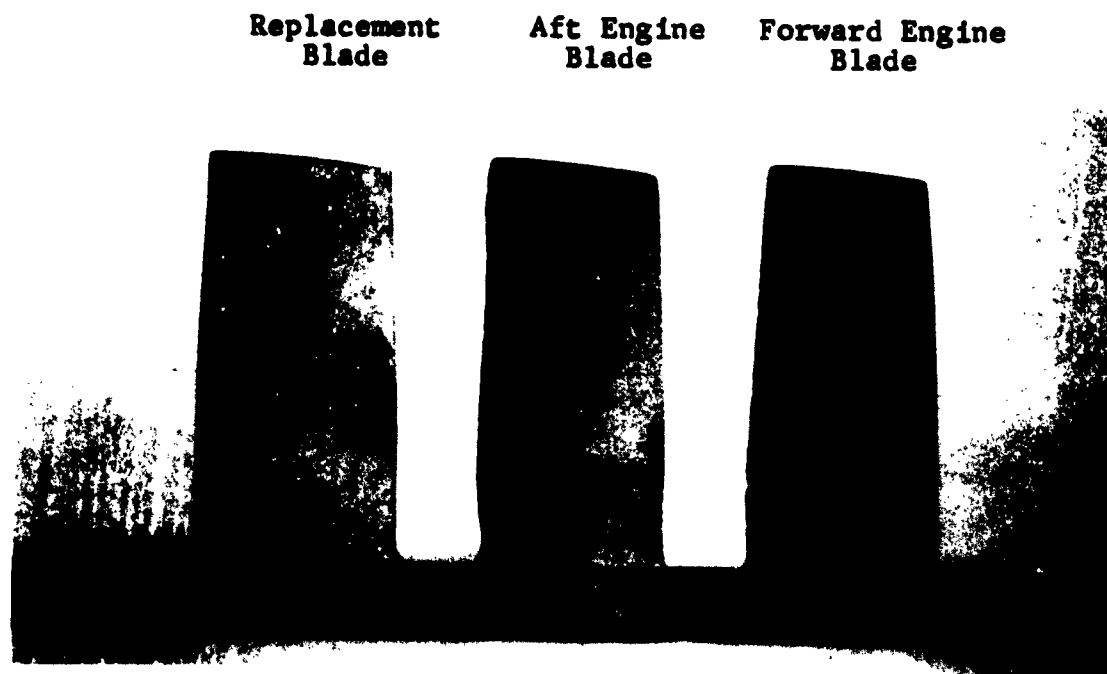
a) Downstream Side Of Blades

b) Upstream Side Of Blades

FIGURE 43. COMPARISON OF FIRST STAGE COMPRESSOR BLADES OF T-53 ENGINES- SHOWING DAMAGE DUE TO SAND INGESTION

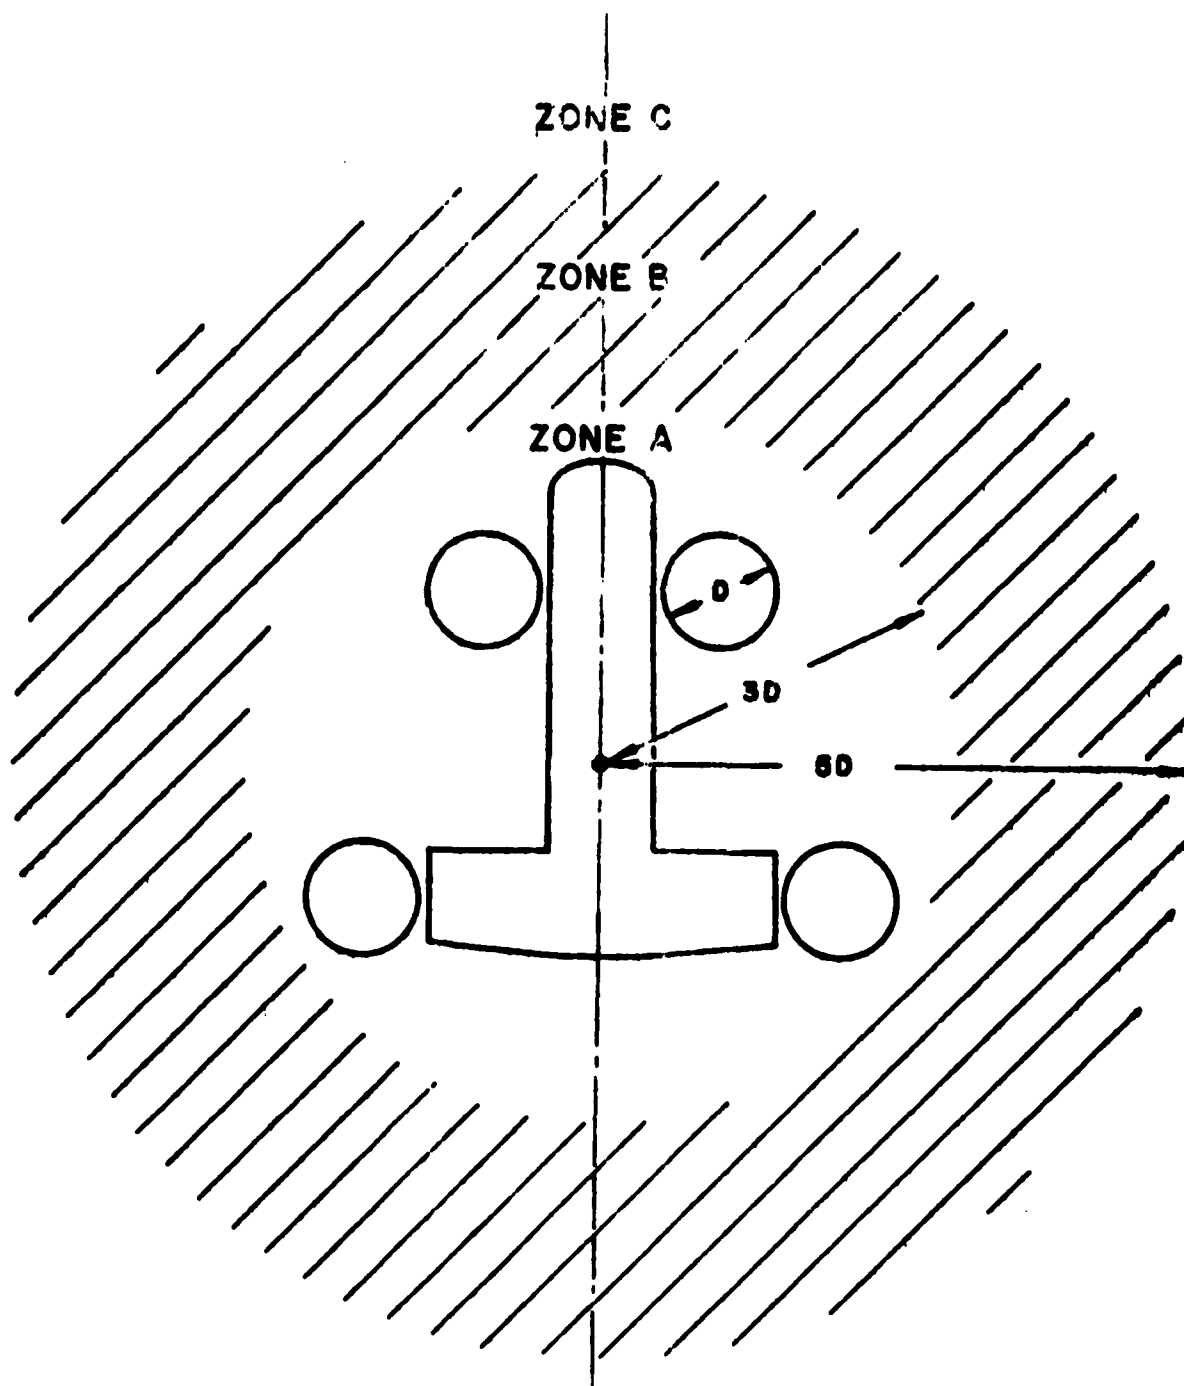
FIGURE 44: ILLUSTRATION OF ZONES USED IN EVALUATING OPERATIONAL ENVIRONMENT

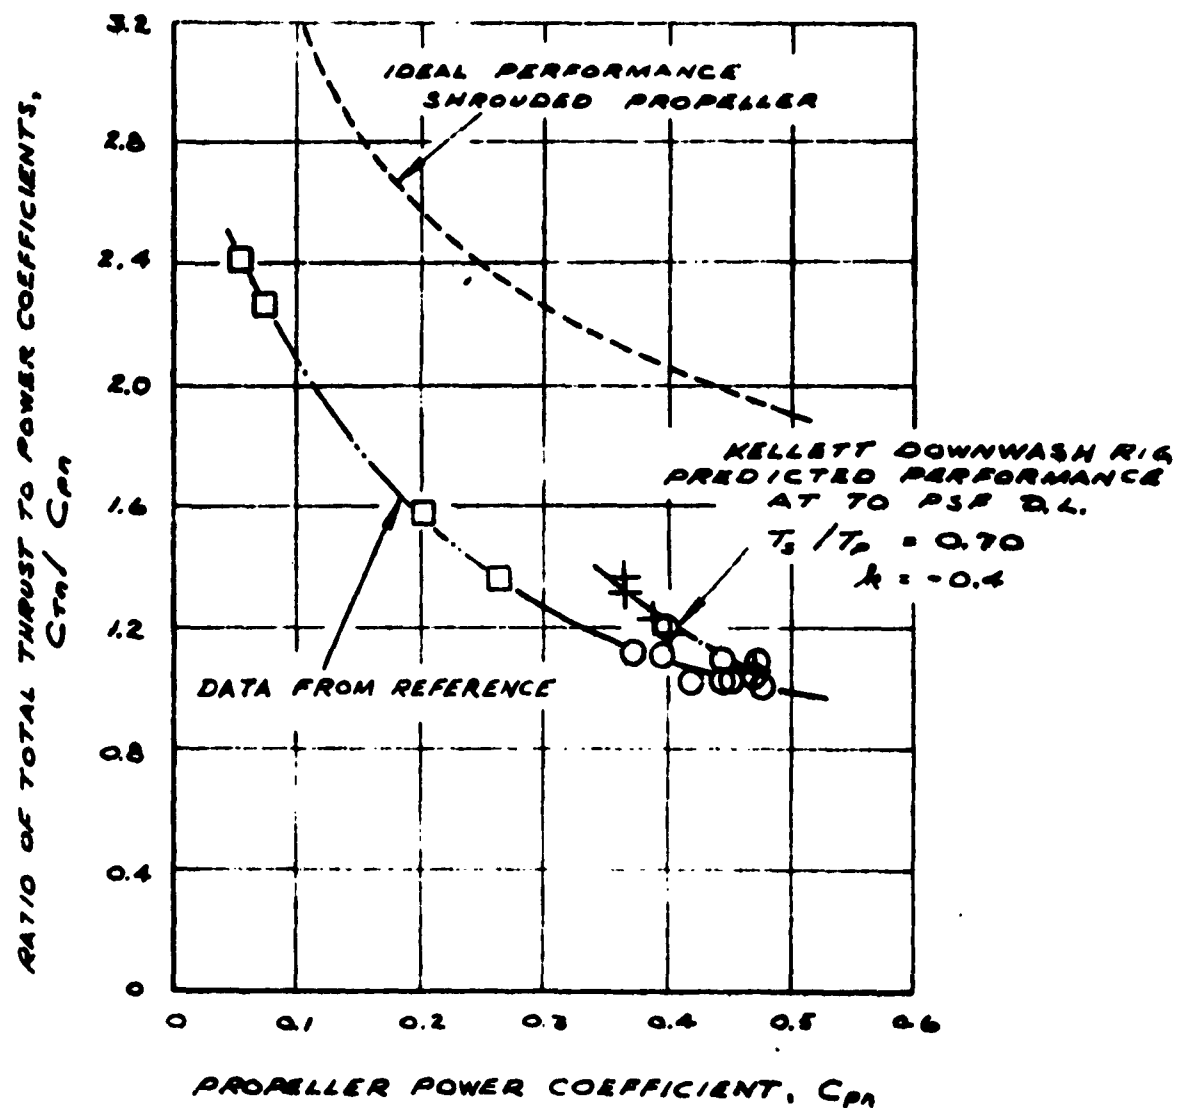
FIGURE 45. COMPARISON OF PREDICTED AND EXPERIMENTAL DUCTED PROPELLER STATIC PERFORMANCE DATA
